Manhole Inspection Summary

Manhole # S21MM_010MH

Insp Date: **7/3/07 9:07 AM**

Location Address: **2729 FULTON-RICHLAND**

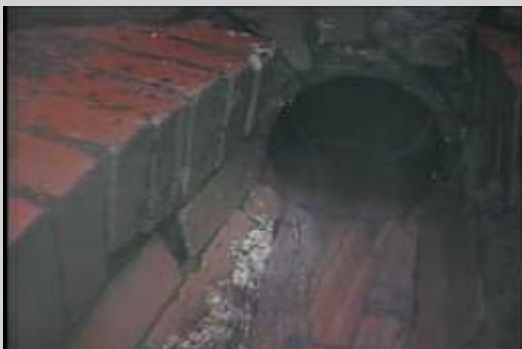
6 O'Clock Inflow

10 in. Circular Gravity Sewer
Pipe In @ 6 O'Clock

Pipe Height: **8.4** (in.) Rod and Bar (Angled)
Pipe Material: **Clay** ☐ Pipe Lined
Invert Depth: **9.25** (ft.) Flow Characteristics: **Fast**
Deposits: ☒ None ☐ Mud ☐ Sludge ☐ Debris ☐ Grease
Silt Depth: (in.) Deposits Extent:
Infiltration: **None** Pipe Seal Cond: **Sound**

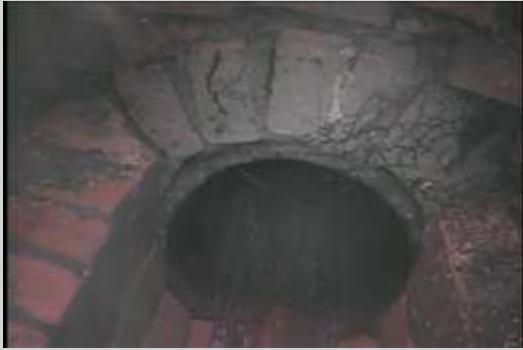
9 O'Clock Inflow

10 in. Circular Gravity Sewer

Pipe In @ 9 O'Clock

Pipe Height: **8.4** (in.) Rod and Bar (Angled)

Pipe Material: **Clay** ☐ Pipe Lined

Infiltration: **None** Pipe Seal Cond: **Sound**
